ADVANCED METALLIC AIR VEHICLE STRUCTURE PROGRAM

GENERAL DYNAMICS
FORT WORTH DIVISION

JUNE 1975

FOURTH INTERIM REPORT ✓
TECHNICAL REPORT AFFDL-TR-75-40

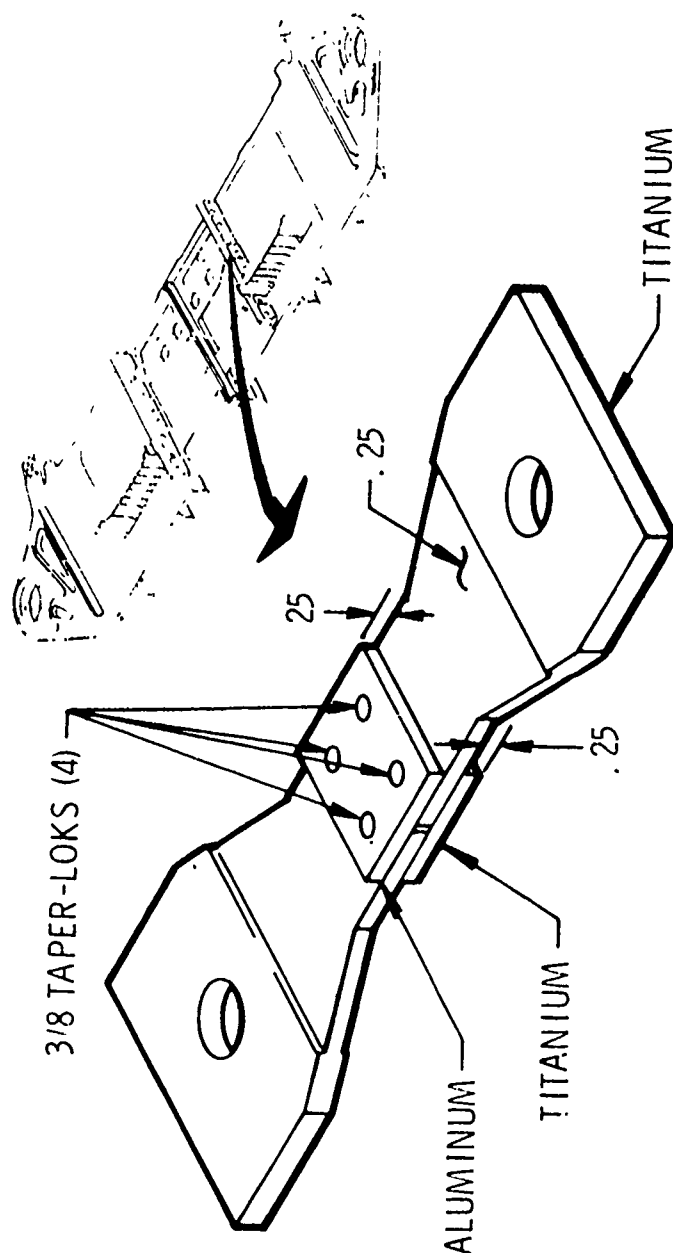
● 602 TB061

Figure 2.2.2.2-2 CREDIBLE OPTION FASTENER EVALUATION PROGRAM -
XF 39 LOWER SURFACE SPLICE

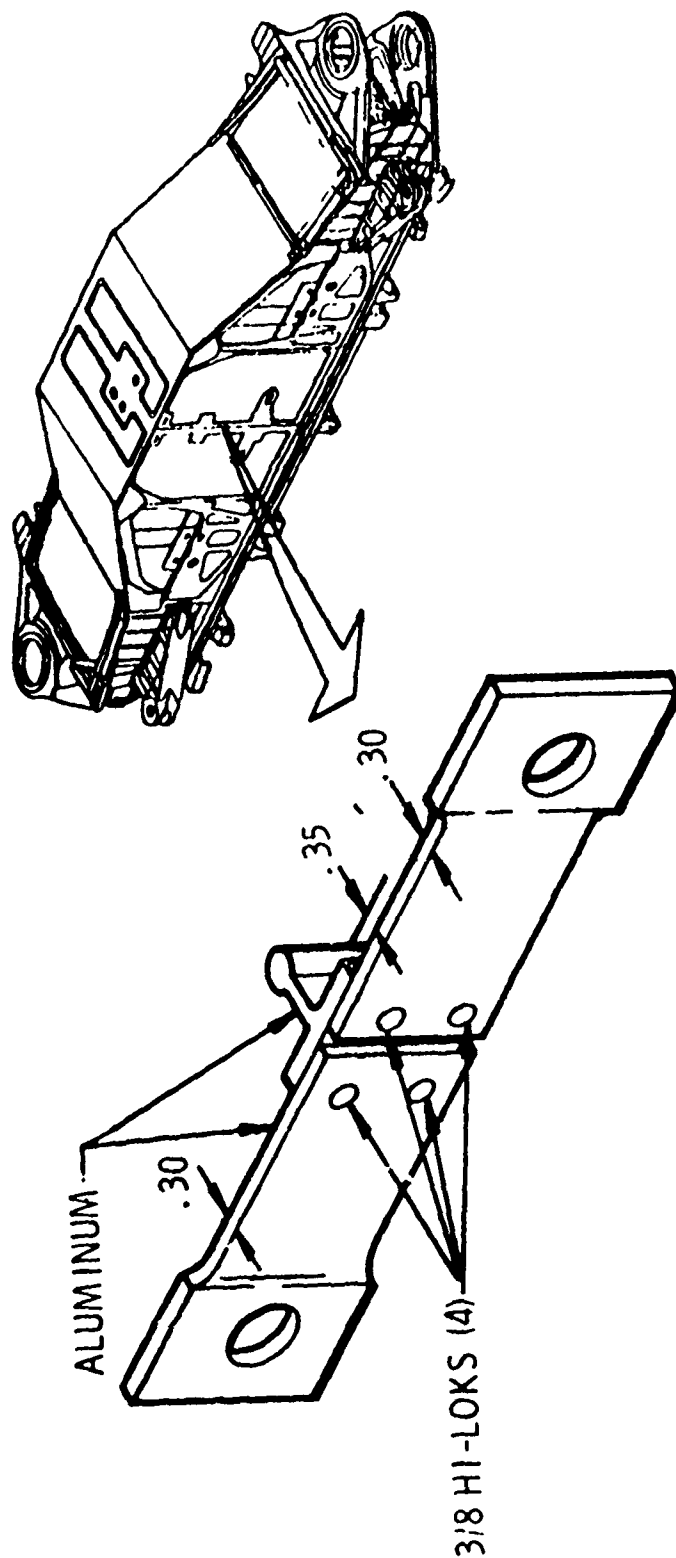
●603FTB069

Figure 2.2.2-4 CREDIBLE OPTION FASTENER EVALUATION PROGRAM -
932 WEB SPICE

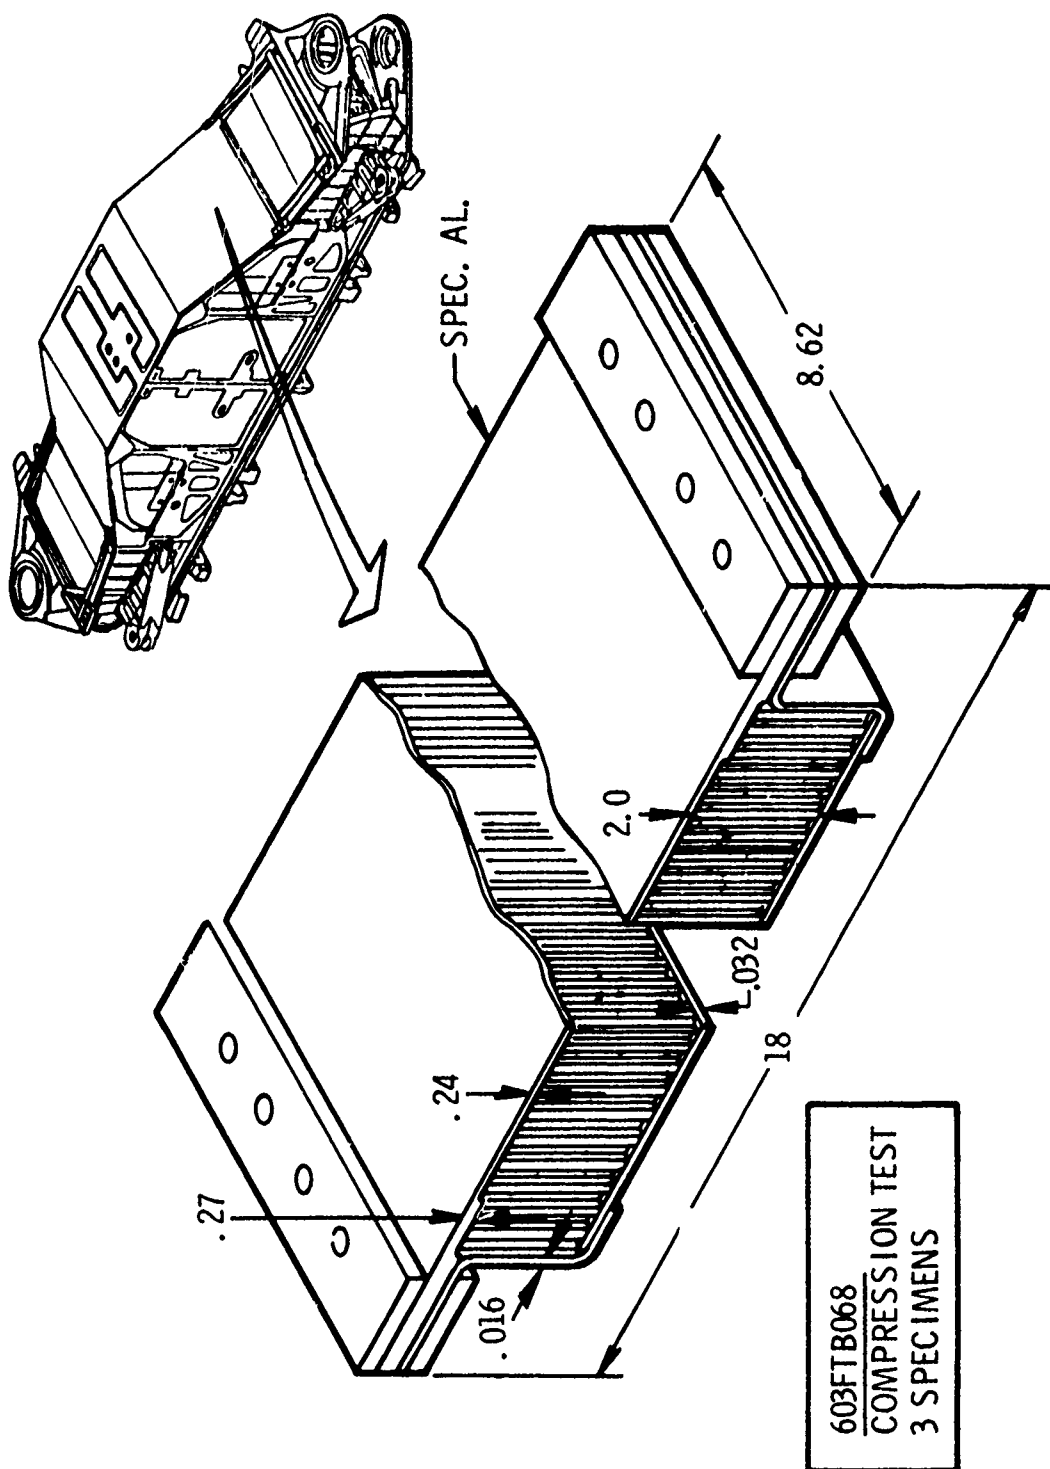
Figure 2.2.2.2-5 CREDIBLE OPTION FASTENER EVALUATION PROGRAM -
UPPER SURFACE SANDWICH PANEL COMPRESSION TEST

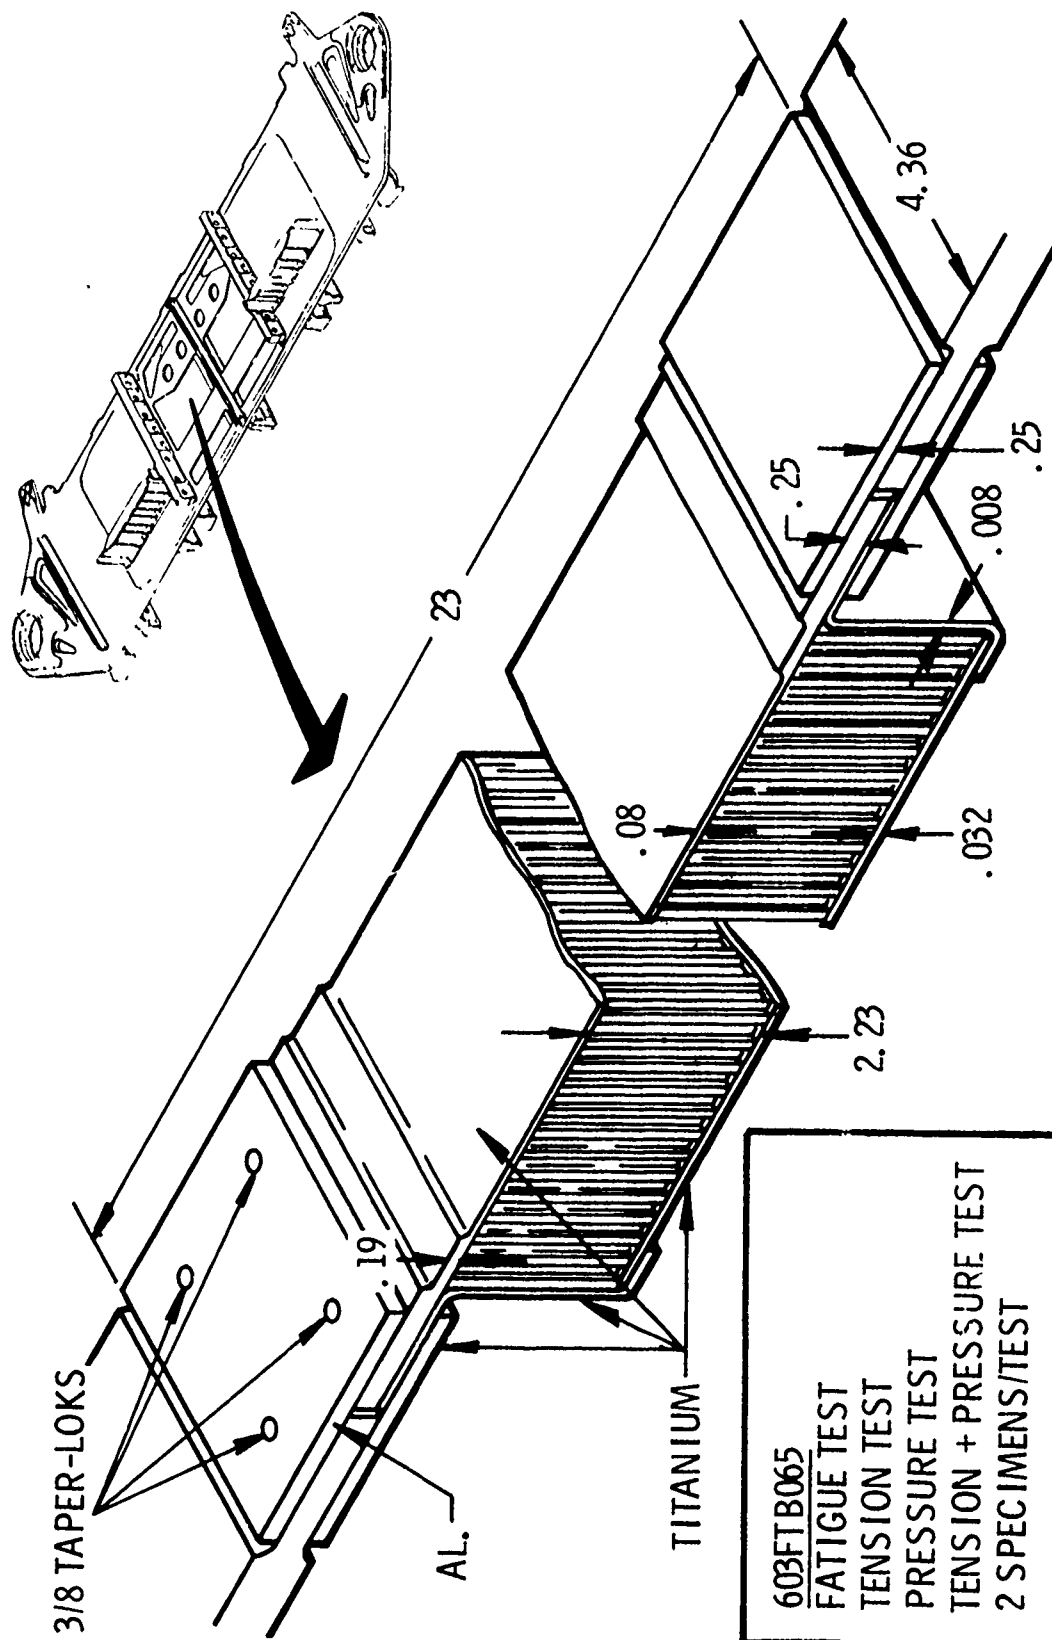
Figure 2.2.2-6 CREDIBLE OPTION FASTENER EVALUATION PROGRAM-
LOWER SURFACE SANDWICH PANEL

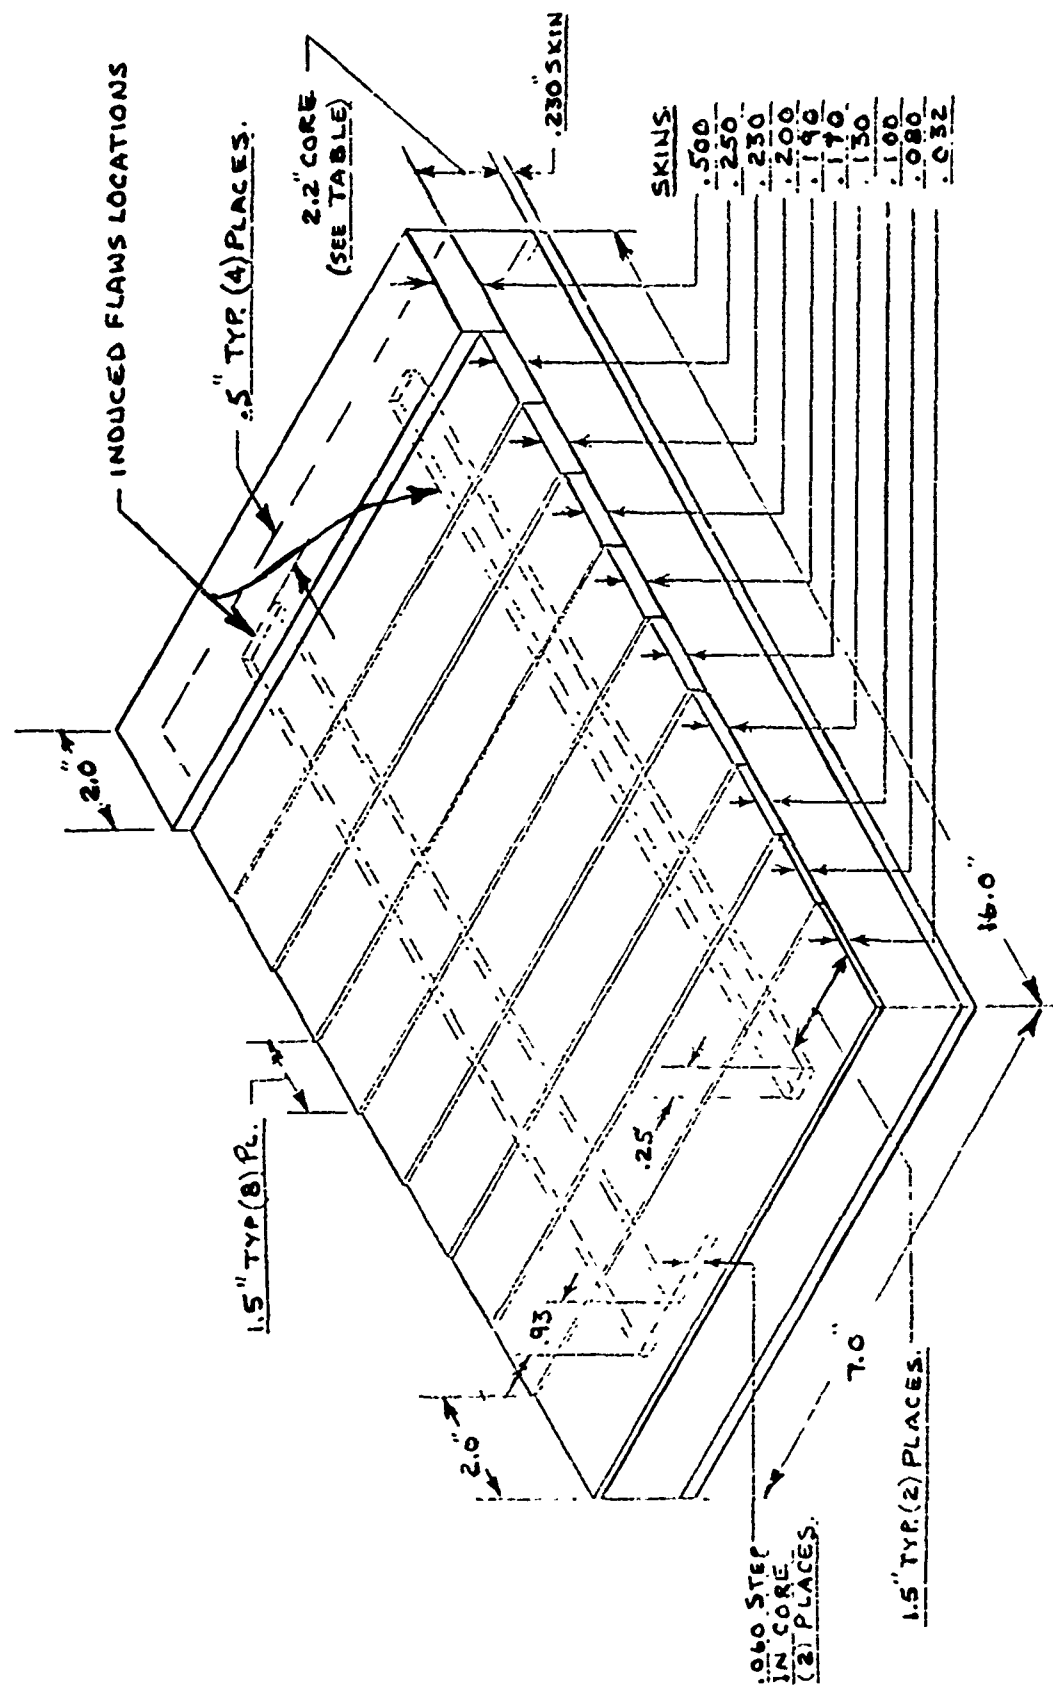
Figure 3.3-1 TYPICAL BONDED REFERENCE PANEL

A total of thirty-four (34) nondestructive bonding test standards were manufactured for use in the preparation of Non-destructive Testing Standards (NDTS) and inspection of production bonded assemblies. These test standards were designed and manufactured to simulate the various skin gage thicknesses, materials, core densities, and core heights. Figure 3.3-1 shows a typical bonded test standard reference panel. Each test standard had a combination of induced flaw sizes to represent the minimum and maximum flaw detection requirements as stated in FPS-1092 - Processing and Quality Control of Adhesive Bonded Assemblies. Each test standard was evaluated after being manufactured to determine its condition and to verify that it contained induced flaws. This evaluation was accomplished by using through transmission ultrasonics and recording the results on data paper through a "C" scan system. Once the evaluations were complete the specific NDI technique was verified against the test standard and inspection procedures (NDTS) were prepared.

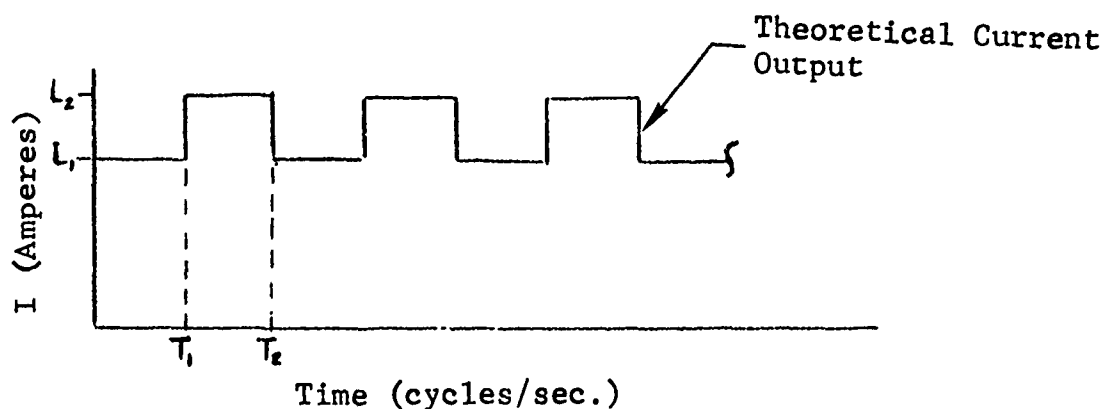
The theoretical arc pulsation welding mode is depicted in the following graph.

- L_1 = Amperage setting at Level 1
- L_2 = Amperage setting at Level 2
- T_1 = Time duration at L_1 current level
- T_2 = Time duration at L_2 current level

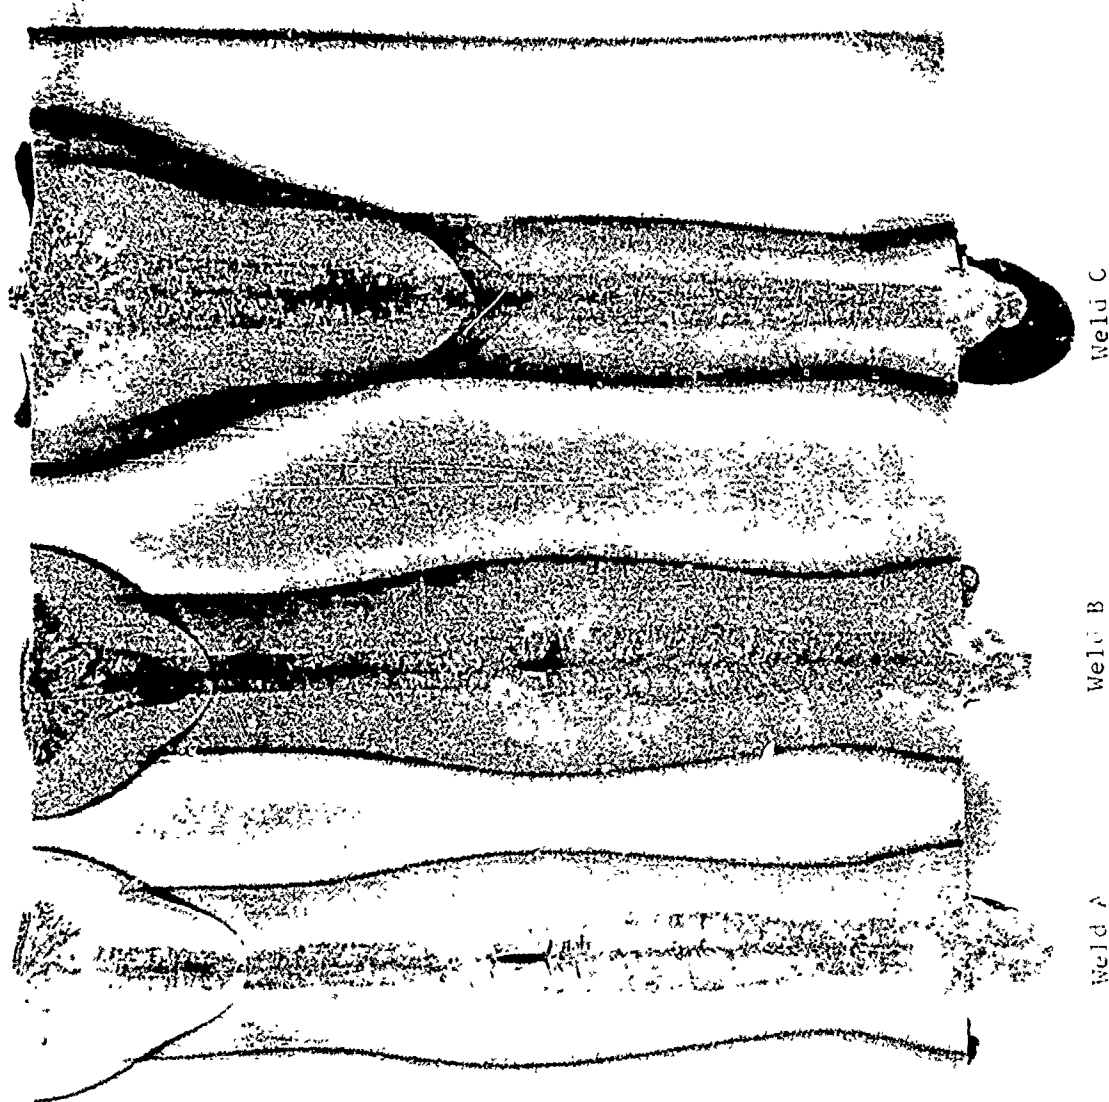
Figure 4.1.5-2 shows the types of hot tears that are typical of welds made when the center of the welds cooled last. Weld "A" and "B" were made with the same parameters for the first pass, on the second or face pass of weld "B" the beam power level was reduced. It should be noted that no root cracks occurred as long as the face pass was made at a low power level. Weld "C" clearly shows the effects of a face pass made with too much beam power.

Weld A Weld B Weld C
Figure 4.1.5-2 TYPICAL WELD HOT TEARS

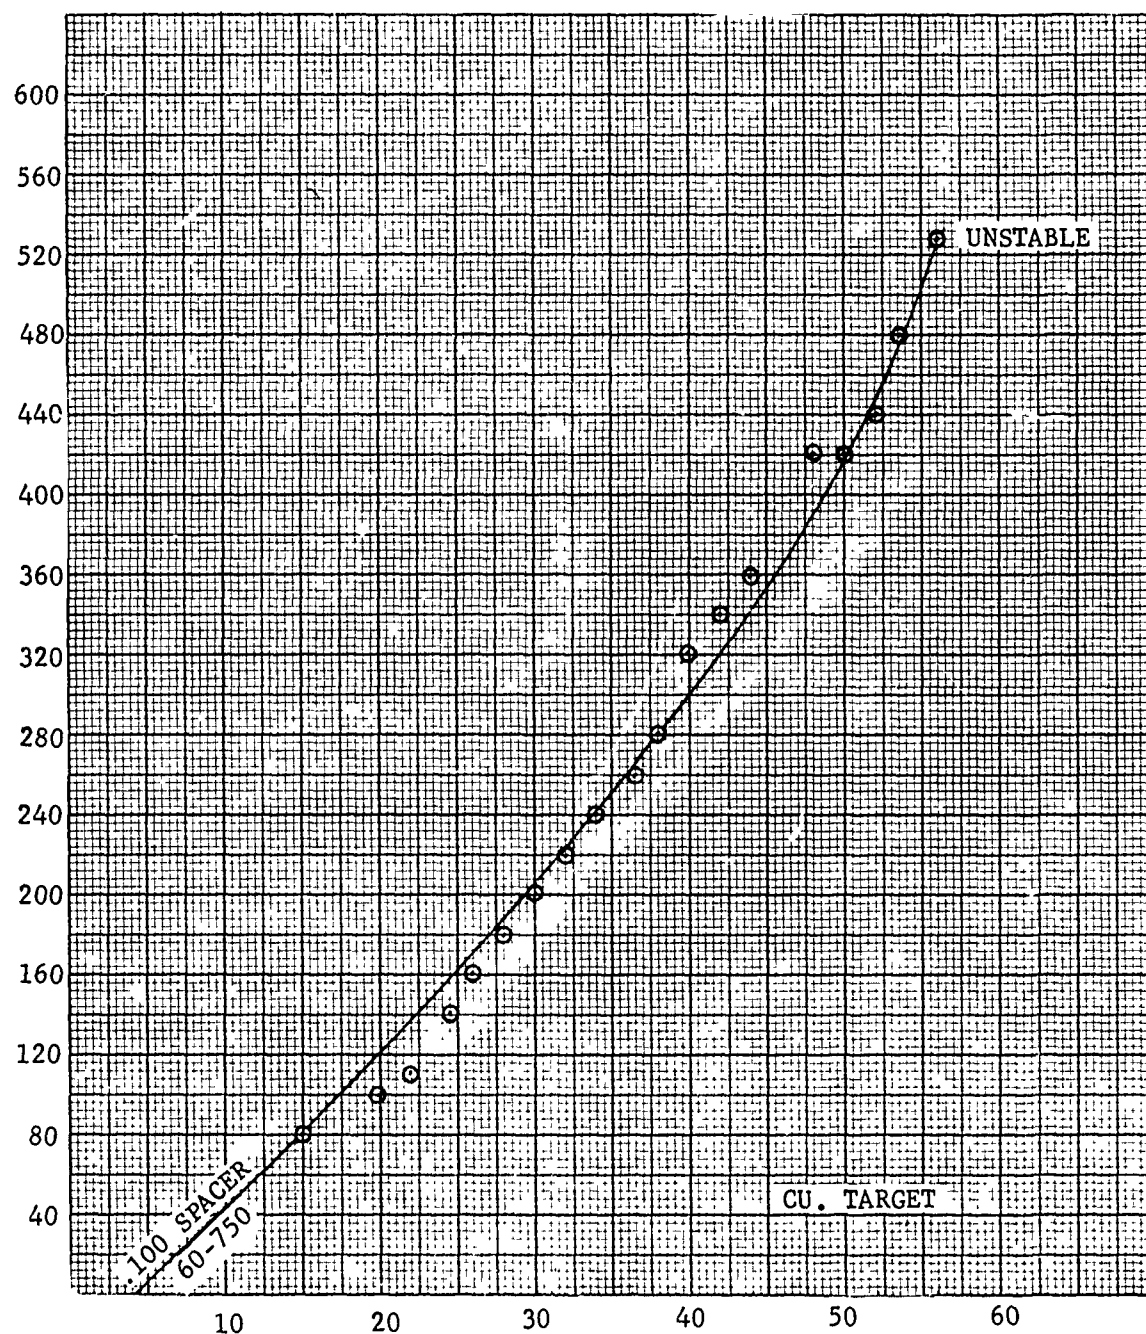
Bead on plate welds were made to examine the weld cross section and to find the exact volt-amper combination that would produce a parallel sided weld geometry. The .100" spacer was found to produce the output curve shown in Figure 4.1.5-5. This proved to be the best EB gun mode and was used on all test and production parts. The high voltage low current beam was adequate to penetrate the 1.8" steel and produce a uniform cross section bead profile. The EB gun was stable and very few "arc outs" occurred.

Figure 4.1.5-5 VOLT AMP CURVE WITH .100" SPACER

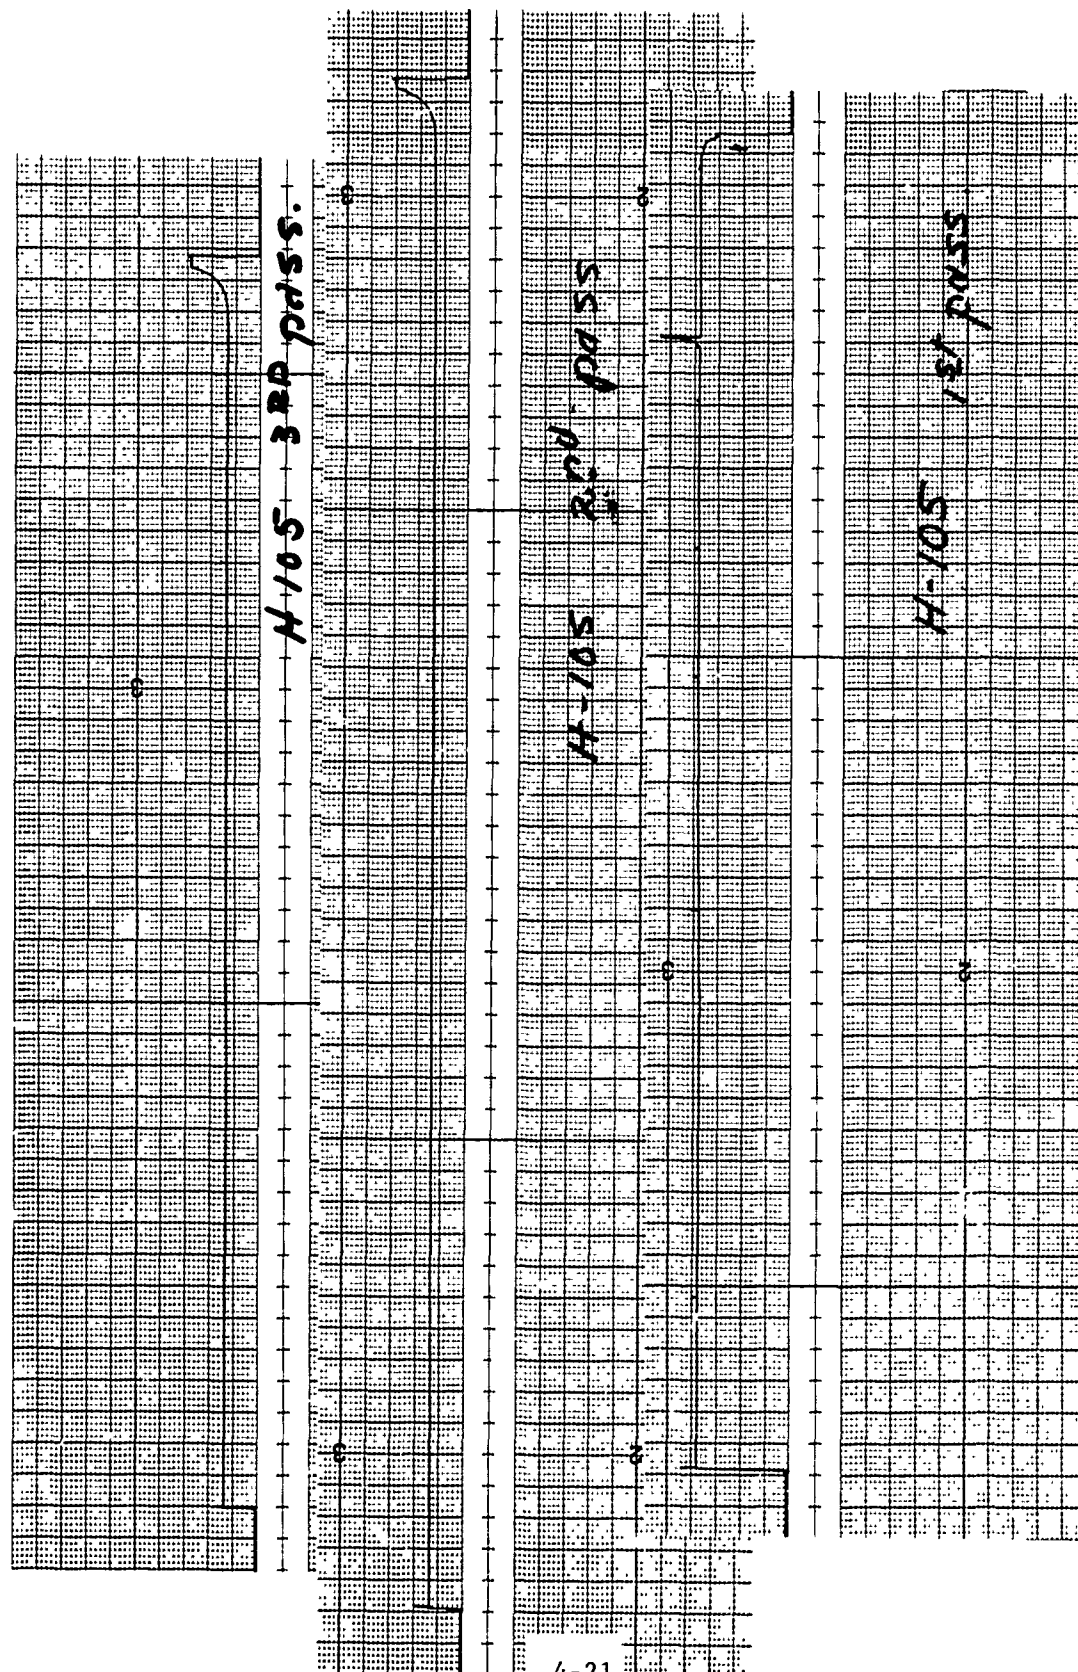
Figure 4.1.5-6 TYPICAL BEAM CURRENT OSCILLOGRAPHIC TRACE

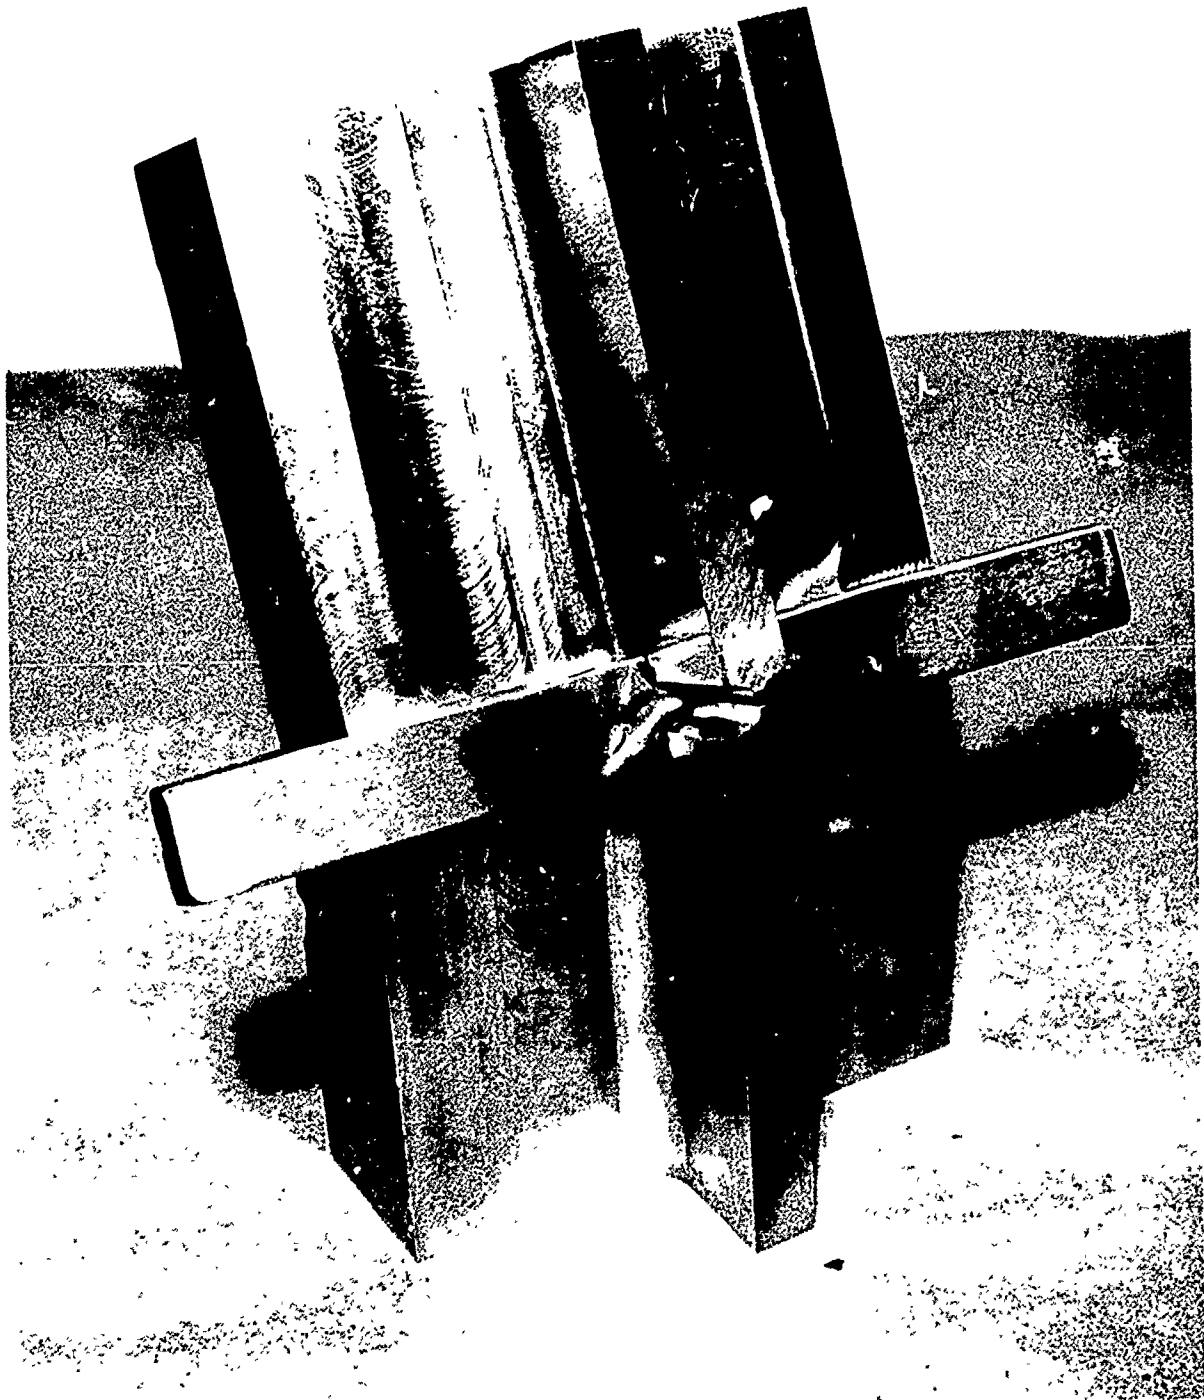
Figure 4.1.5-8 TEE SECTION (SIMULATED CAP WELD) WITH
.5" DIA. AND GROOVED BACK UP IN PLACE

The original bulkhead cap assembly had a .5" relief hole located at the intersection of cap and lower flange as shown in Figure 4.1.5-8. Test welds on this configuration proved to be satisfactory (see H-99, H-100 in appendix) for both the 1.6" and 1.8" thickness with the exception of minor backwelding required after the back up was removed. However, when the first full scale part was welded, the round grooved back up shown in Figure 4.1.5-9 did not absorb the penetrating beam energy and the resultant weld had void areas. (See Appendix H-101.) This was caused by several factors; namely the interface fit of a 140" part reflects the accumulation of several machine tolerances, the copper chill blocks apparently slipped when the parts were mated. To eliminate this occurring again, design engineering was requested to change the .5" diameter hole to a .625" x 1.00" rectangular relief. (See Figure 4.1.5-9.) This relief area was closed at the same time that the manual GTA weld on the T-leg

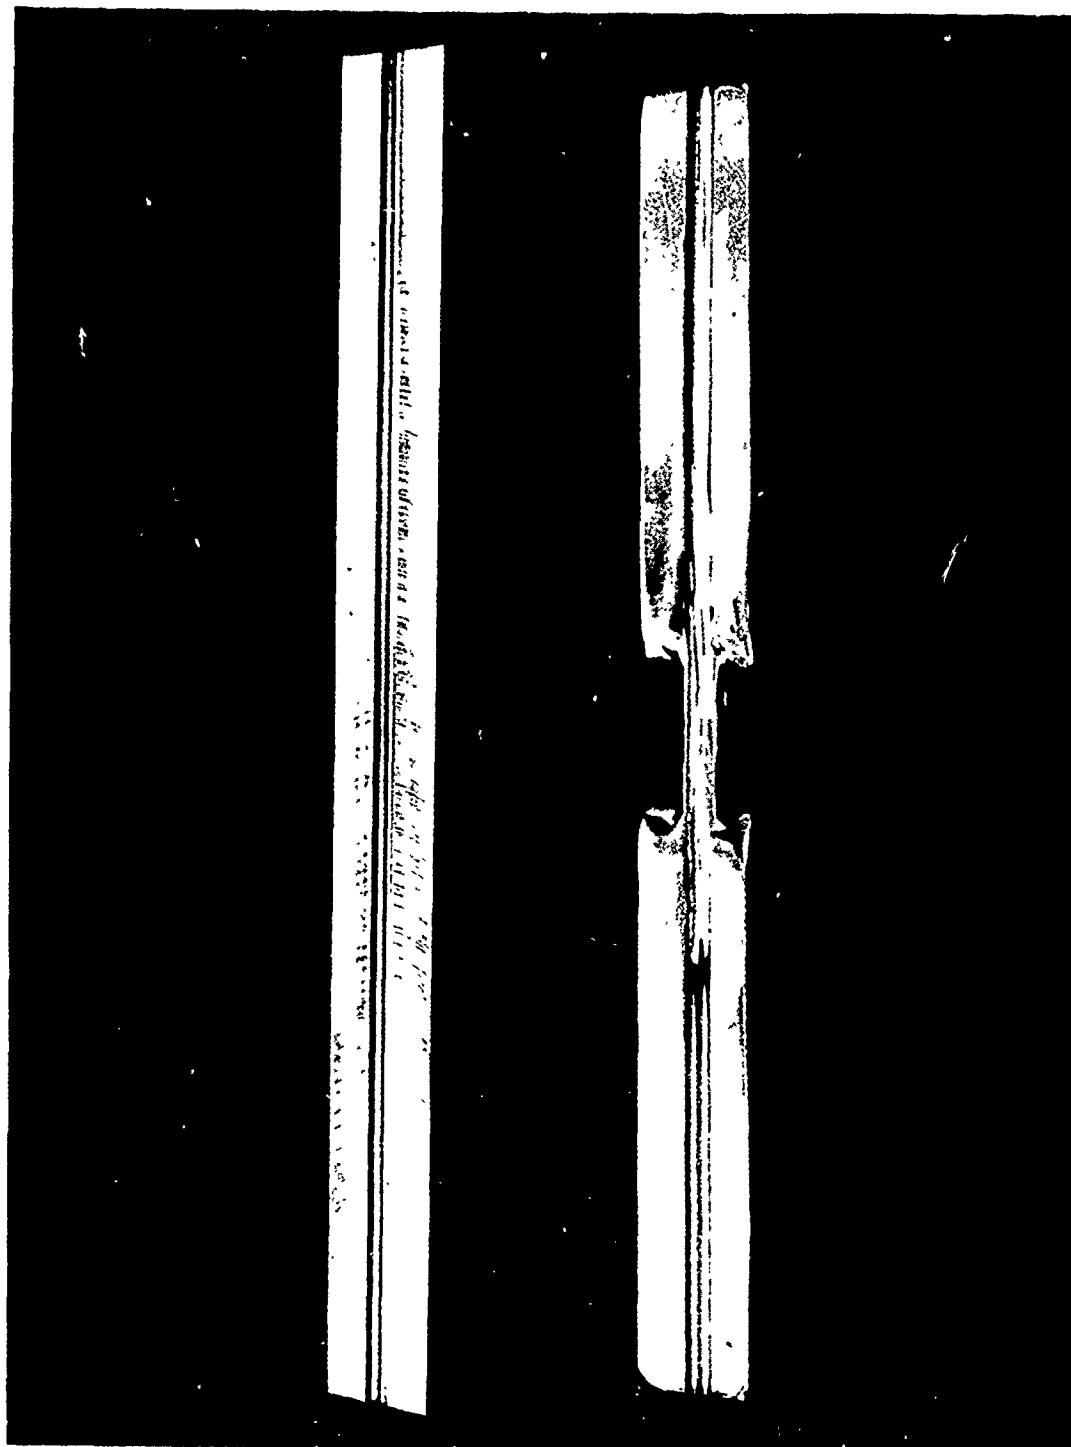
Figure 4.1.5-9 GROOVED BACK-UP BARS
Upper: .625" x 1.00" Rectangular Relief
Lower: .5" Diameter Relief

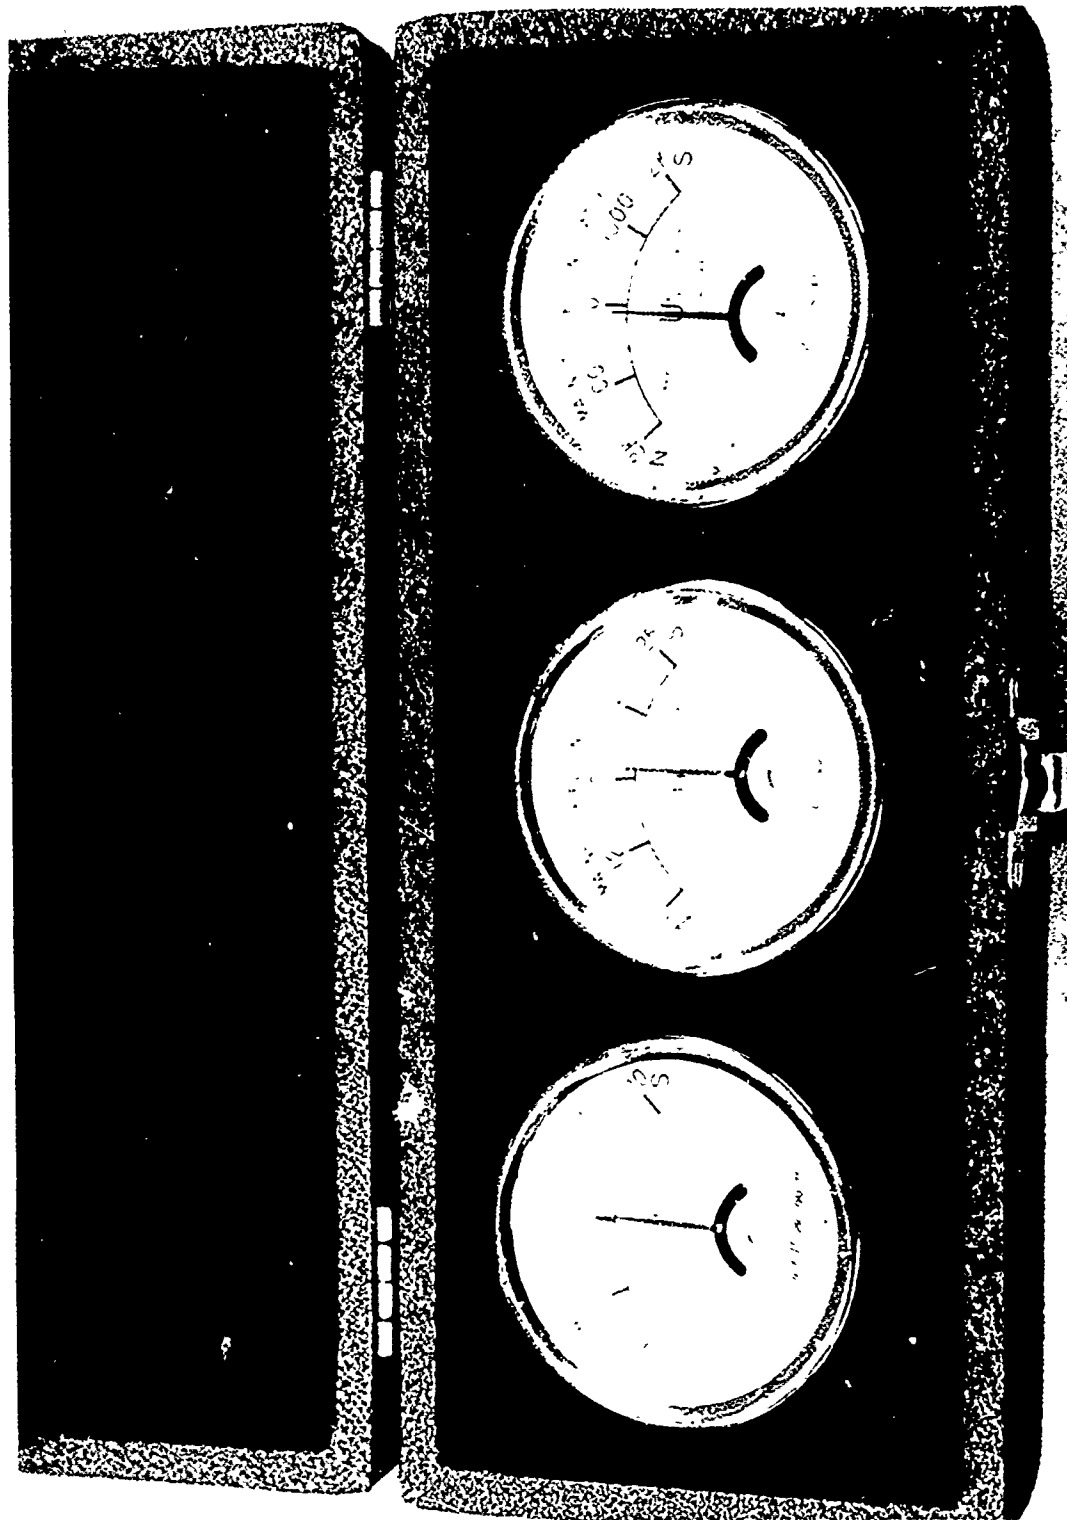
Figure 4.1.5-11 MAGNETIC FIELD STRENGTH METERS

Magnetic field intensities can be measured by quantitative or comparative methods. Quantitative measurements usually involve D'Arsonval-type meters in conjunction with search coils or probes. Such instruments are classed as laboratory equipment and require considerable time and skill to use. Thus they would not be easily adapted to production application. For the purpose of this investigation and for adaptability to production use the comparative method was used. Figure 4.1.5-11 shows the field strength indicators or magnetometers used to measure the fields in the 10 Ni. parts. They are accurate enough for this task and easy to use. All measurements reported in this report were made with this type of instrument. To determine the actual deflection

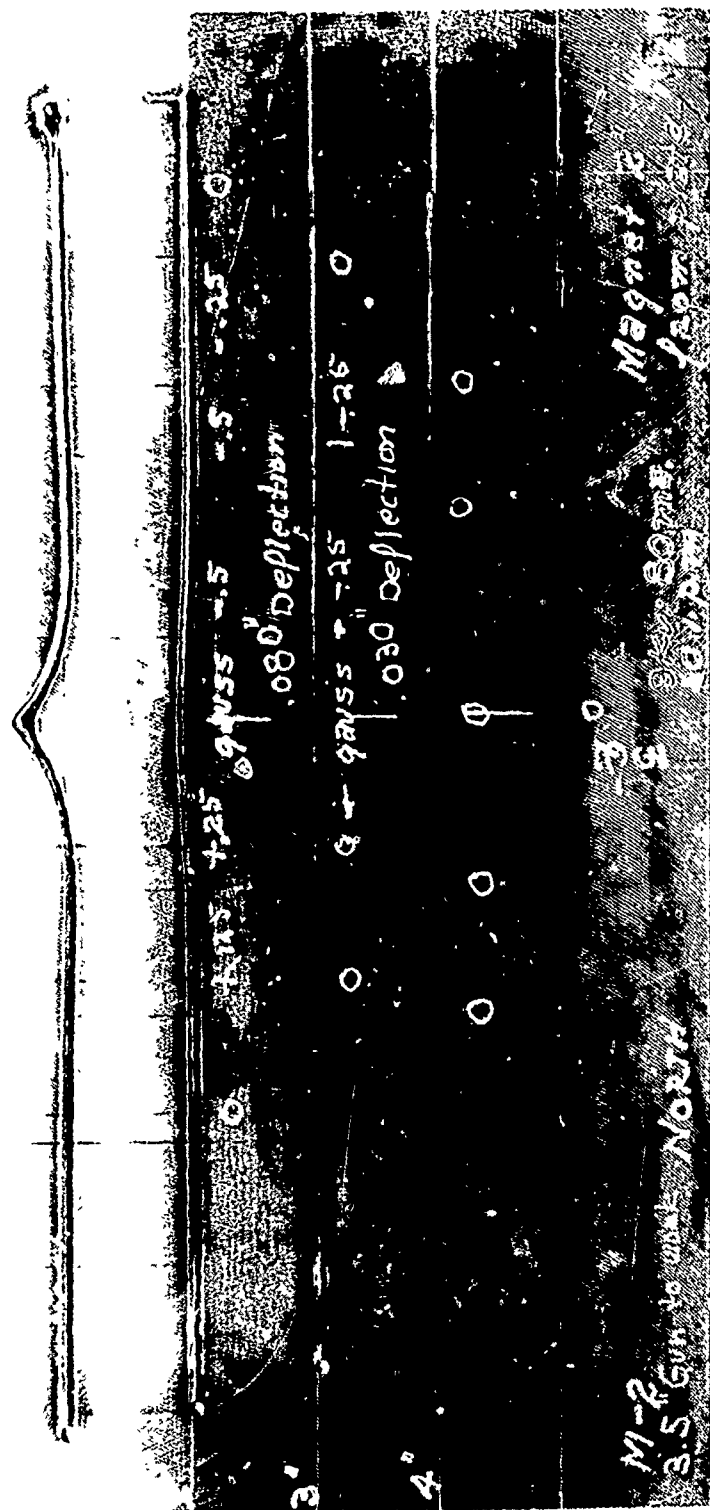
Figure 4.1.5-12 BEAM DEFLECTION TEST PLATE 3.5" GUN TO WORK

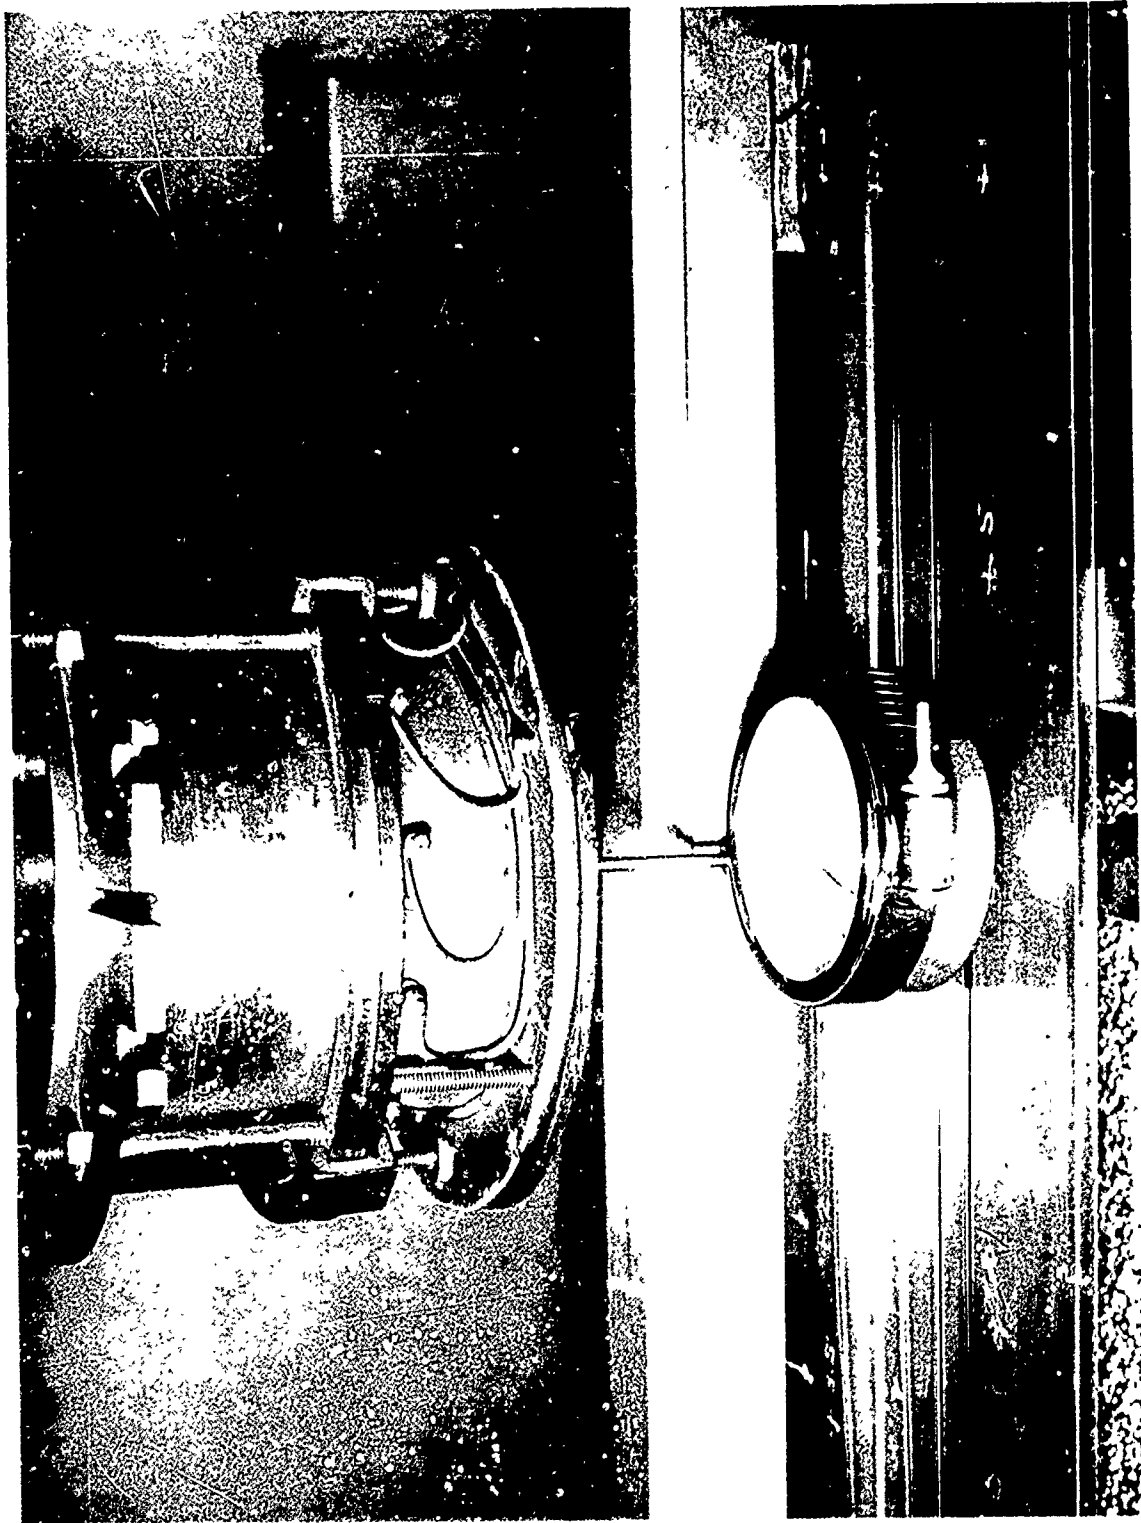
Figure 4.1.5-14 SETUP FOR MEASURING FIELD STRENGTHS

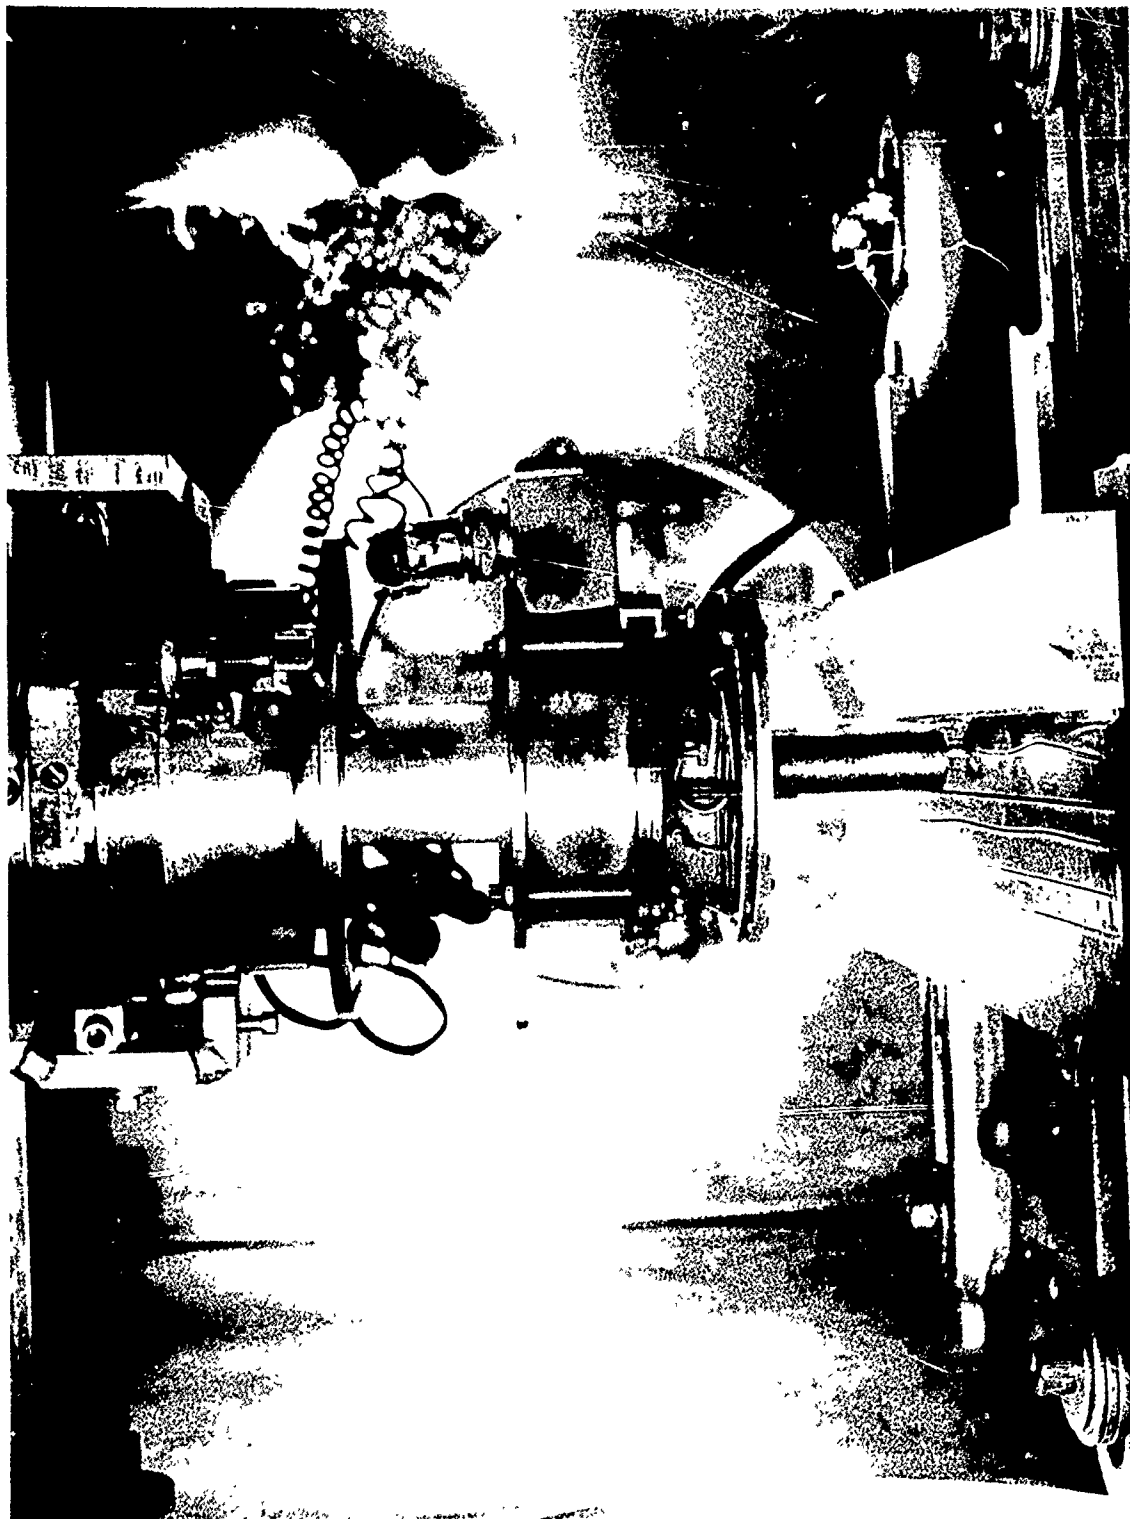
Figure 4.1.5-15 MAGNETIC SHIELD

A method for counteracting the effects of a strong (1 gauss or more) magnetic field on or above the surface of the work is shown in Figure 4.1.5-15. It consists of a soft iron pipe
